CLIENT: GREENSTONE STRUCTURAL SOLUTIONS
6-470 King St. West, Suite 115
Oshawa, ON
L1J 2K9

Test Report No: T1090-2b

SAMPLE ID: Greenstone Structural Solutions 191 mm (7.5 in.) 1.25 mm (18 Gauge) prefabricated steel stud panel with Type 1 Expanded Polystyrene (EPS), 13 mm (1/2 in.) Megrete magnesium oxide (MgO) board and standard 13 mm (1/2 in.) gypsum board.

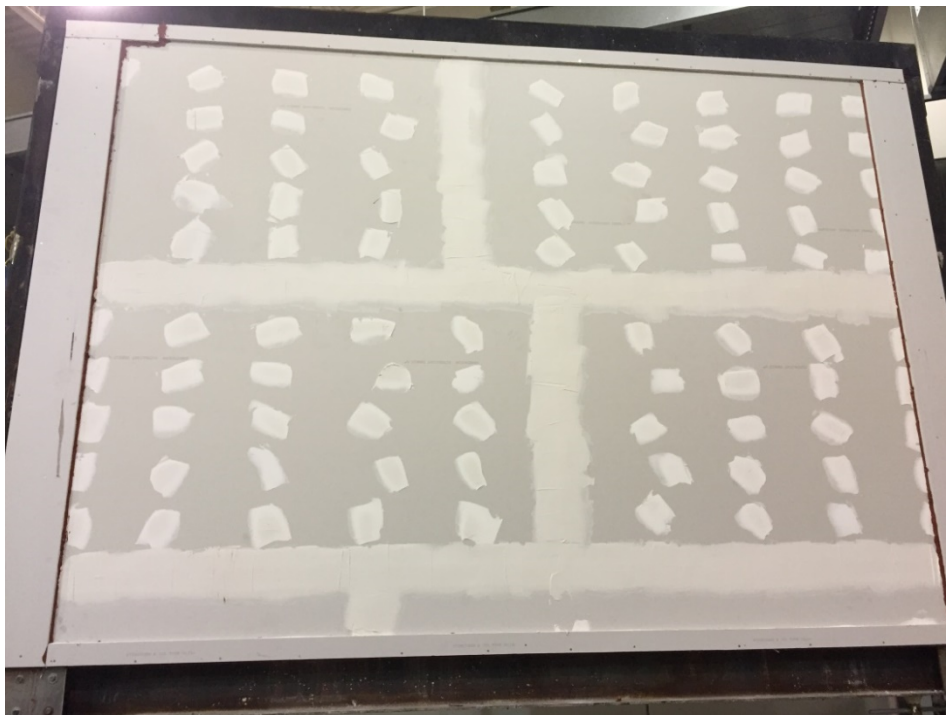
Figure 6: The exposed face prior to the fire test.

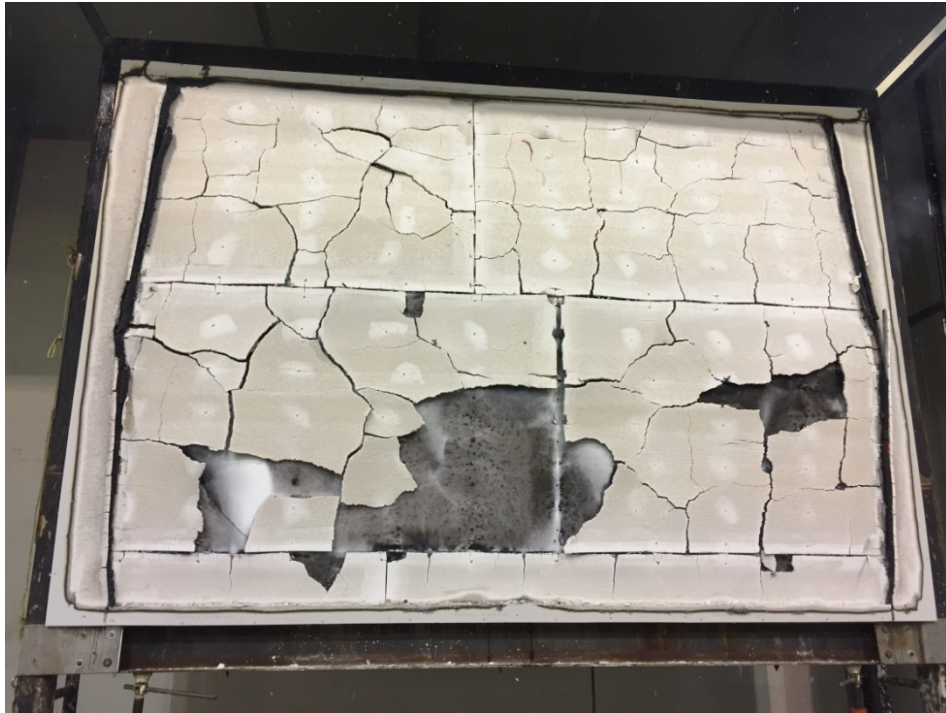
Figure 7: The exposed face after the fire test.

Test Time (min)	Unexposed	Exposed
1:30		Ignition of the surface.
2:45		Surface flaming has self-extinguished.
8:00		The joint tape is beginning to fall off.
13:25		60% of the joint tape remains on the wall.
17:00		90% of the joint tape has fallen off.
22:00		Cracks have formed on the gypsum board.
30:00		More cracks have formed in the gypsum board. No board has fallen from the wall yet.
44:30	Light venting from the vertical MgO joints.	
46:30		Large curvature in the right side gypsum.
49:43		Light flaming at the cracks of the gypsum. Gypsum sections are peeling away from the wall.
57:00	Right side is bowing into the furnace.	
58:42		Heavier flaming at gypsum joints.
60:00	Test discontinued.

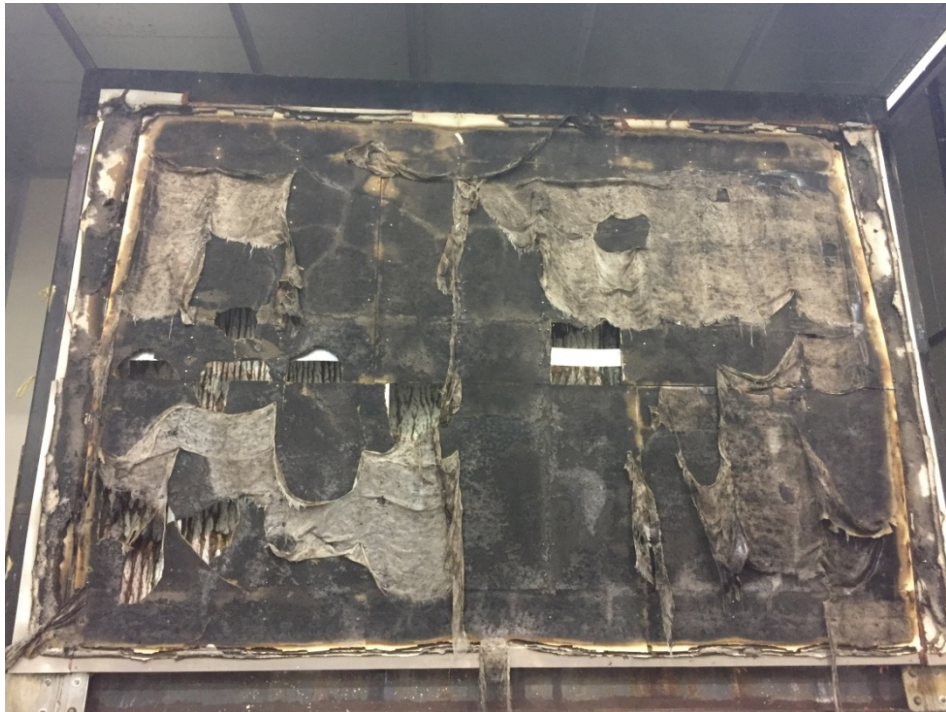
Figure 8: The exposed face after the hose stream test.

Immediately after the fire test, a hose stream test was conducted for 65 seconds. The wall assembly successfully met the conditions of acceptance for the hose stream test: no through openings were developed that would allow a projection of water from the stream beyond the unexposed face during the time of the hose stream test.

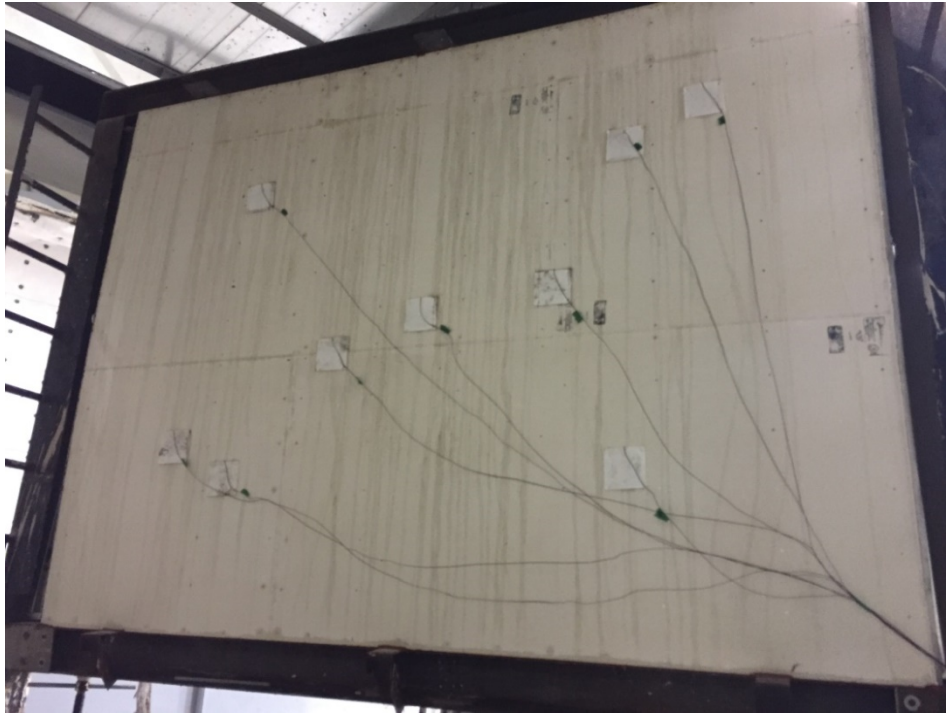
Figure 9: The unexposed face after the hose stream test.
